Anderson, S.W., B. Shattuck, N. Shea, C.M. Seguin, J.J. Miles, D. Marks, and N. Coumou. 2023. River channel response to the removal of the Pilchuck River Diversion Dam, Washington State. *Northwest Science* 97(2): *in press*.

River channel response to the removal of the Pilchuck River Diversion Dam, Washington State

Abstract

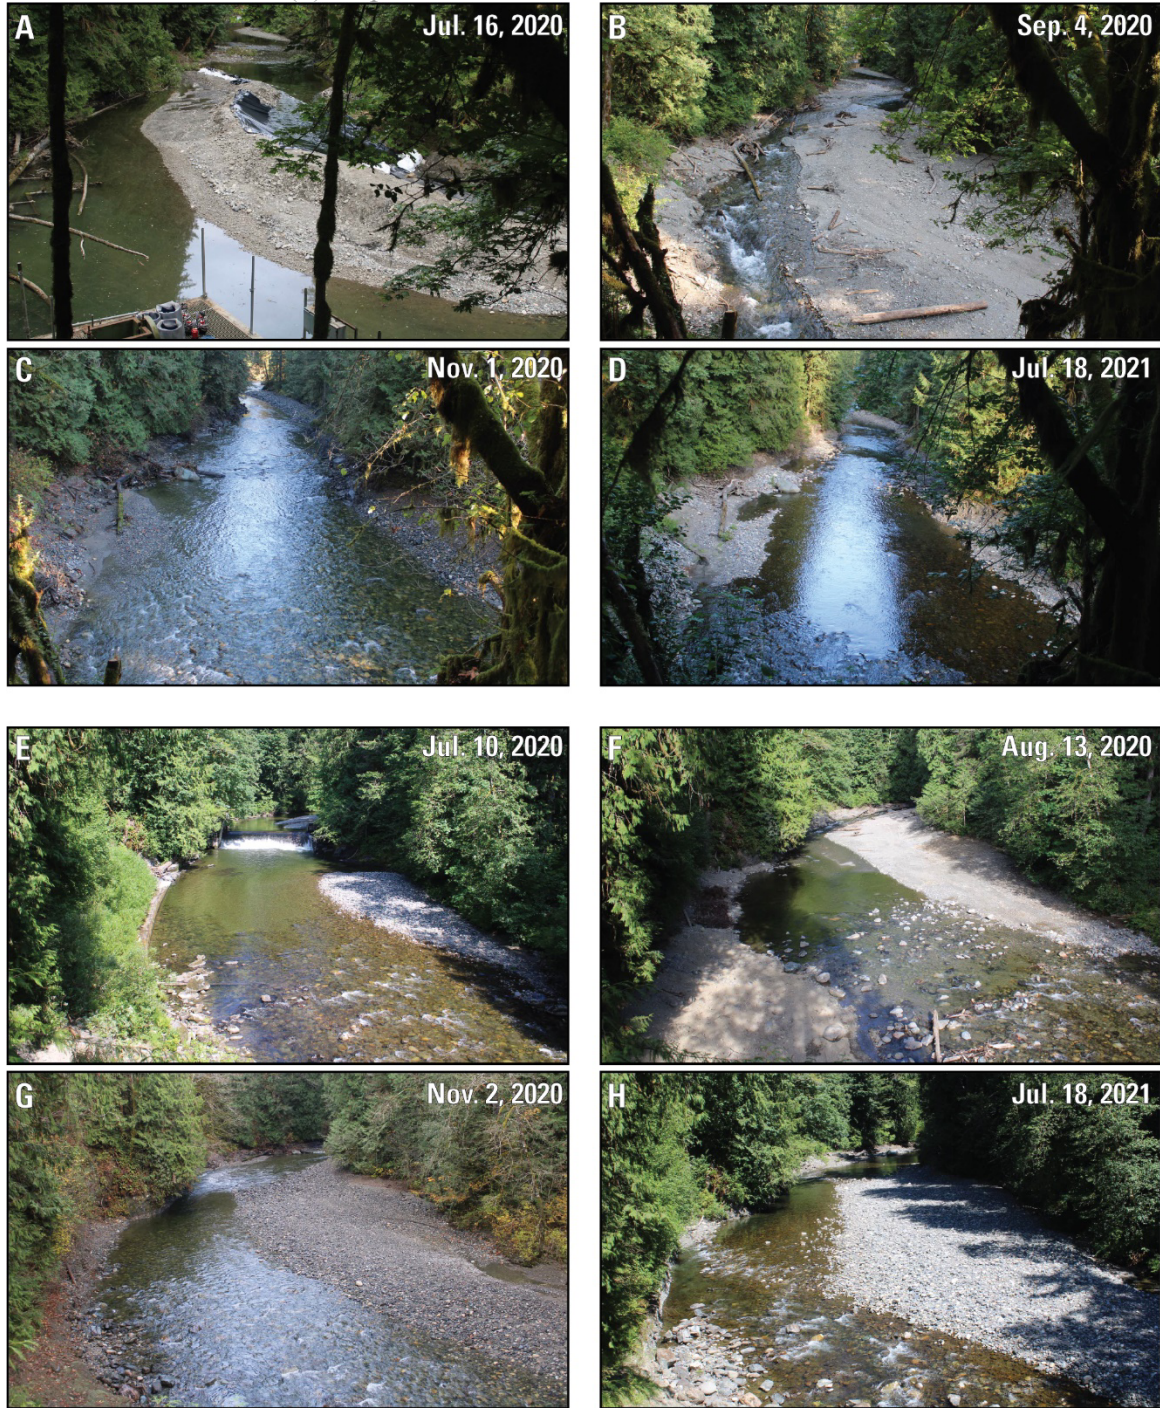
Figure 2. Selected images from the upstream (A-D) and downstream (E-H) time lapse cameras. A) Upstream camera, looking upstream through impoundment reach during early dam deconstruction. Impoundment sediment has already been shifted to create a bypass channel for water. B) Impoundment conditions immediately after dam removal. C) After first high flows; majority of impoundment sediment has been removed at this point. D) At end of study period. E) Downstream camera, looking upstream toward dam prior to removal. F) Conditions immediately after dam removal; gravel bar on river left was formed through manual grading of impoundment sediment. G) After first high flows. H) At end of study period. Timing of photos relative to discharge from the Snohomish County stream gauge at Menzel Lake Road shown in (I), with asterisk indicating completion of the dam removal.

Two time lapse cameras were installed and used to qualitatively assess channel change near the dam site. Both installations used a 24.1 megapixel Canon EOS Rebel T7 camera shooting at one-hour intervals. One installation was located on river-right about 100 m downstream of the dam, looking back upstream toward the dam (Figure 1). We refer to this as the downstream camera. The second installation was located on river-right directly adjacent to the dam site, looking upstream through the impoundment reach. We refer to this as the upstream camera. Both cameras were installed July 2020 and took photos through July 19, 2021.

Once flows began to rise in the Fall of 2020 (Figure 2I), erosion of the remaining sediment stored in the impoundment reach was rapid and largely accomplished within several months of the dam's removal. Time lapse imagery shows that substantial river-driven erosion of impoundment sediments started during a series of minor flows in mid-September 2020, with peaks up to 28 m³/s. Most of the remaining impoundment erosion occurred over a series of moderate peaks between 50 and 80 m³/s through late October 2020. By early November 2020, the impoundment reach was largely devoid of exposed gravel surfaces, and, despite multiple high flows up to 140 m³/s, there were no visually obvious changes to impoundment-reach geometry over the rest of the monitoring period (Figure 2).

The physical river response to the Pilchuck Dam removal was both modest and rapid. Essentially 100 percent of impoundment sediment was evacuated within months after dam removal, with modest flows doing much of the work (Figures 2, 3). Significant downstream channel adjustments were spatially limited to the first 350 m below the dam, and the downstream channel was sufficiently stable by January 2021, six months after removal, that multiple subsequent high flows near or above the 0.5 AEP flow caused little observable channel change (Figure 5).

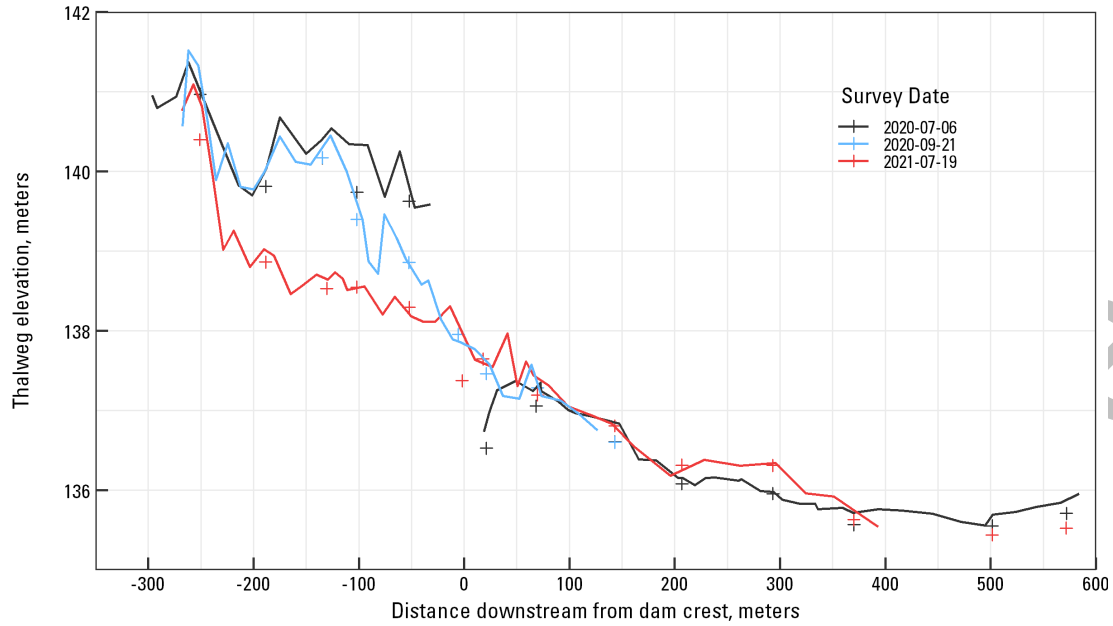
Figure 4. *Approximate channel thalweg of the Pilchuck River before and after removal of the Pilchuck Dam. Lines represent total station longitudinal profile surveys; crosses are minimum elevations extracted from cross sections surveys.*

A steep riffle, flowing over a mixed bedrock/cobble bed, formed at the upstream edge of the impoundment reach (Figure 4). This bedrock-controlled step marked the limit of substantial erosion upstream of the dam, consistent with pre-removal expectations. A total of 7,400 m³ was removed from the impoundment over the one-year monitoring period, lowering much of the reach 1-2 m (Figures 3, 4).

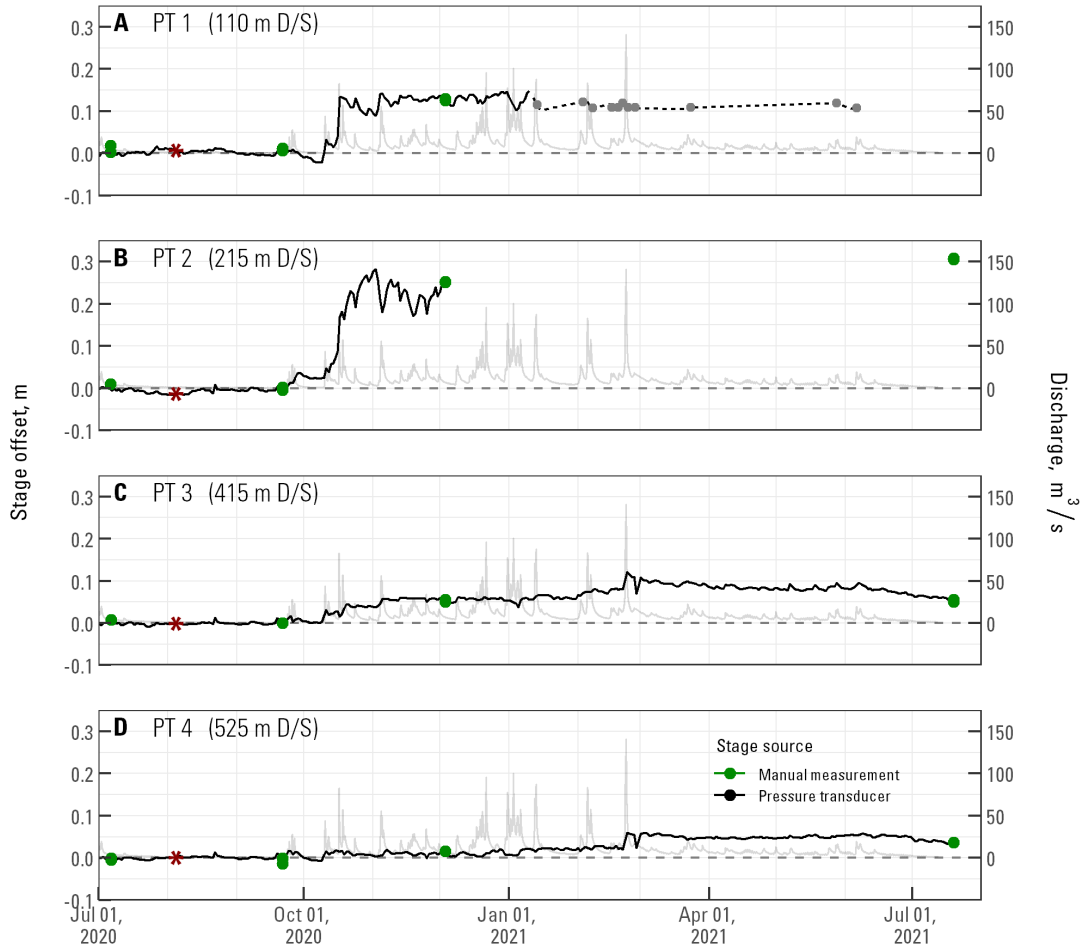
Figure 5. Stage offsets based on stage monitoring downstream of the Pilchuck Dam. Stage offsets provide an approximate measure of changes in mean channel bed elevation near the site of a given pressure transducer. Asterisks indicates timing of dam removal. Dashed line and points in A reflect analysis of PT 1 records after partial burial by sediment – see methods. Stage offsets based on manual stage measurements are shown (green points) to validate datum consistency at all sites and, for PT 2, to provide a point estimate of relative channel elevations at the end of the study.

aggradation (~0.05 m) may have occurred in the low gradient reach 400-500 m downstream of the dam (Figure 5C, D).

Continuous estimates of bed elevation change based on stage monitoring provide a more detailed look at the timing of these downstream changes (Figure 5). At PT 1 and 2, most vertical channel adjustments were accomplished by moderate events in October 2020. After October 2020, elevation at the two sites varied only modestly, with no substantial net change through July 2021. Modest deposition at PT 3 (~0.1 m) occurred in two steps during October 2020 and late-February 2021 high flows, while deposition at PT 4 (~0.05 m) occurred only during the late-February peak.
